# Home Sewer Line Issues A Guide for Orange Hunt Estates Homeowners

By Gary Koblitz  
OHECA President  
May 2026

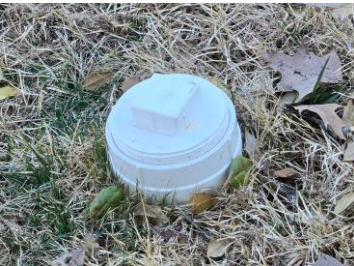
Some homes have one or two clean-outs exposed in the front yard, which mark the location of the lateral. The clean-outs normally are associated with post-construction lateral repair or replacement that necessitated trenching down to the lateral. They provide future camera inspection and cleaning device access. Two homeowners reported clean-outs that apparently are associated with the original lateral emplacement: A cast iron cleanout in an older home and an ABS one in a newer home. However, this situation seems rare based on homeowner responses and its uniqueness to these two homes is unexplained.

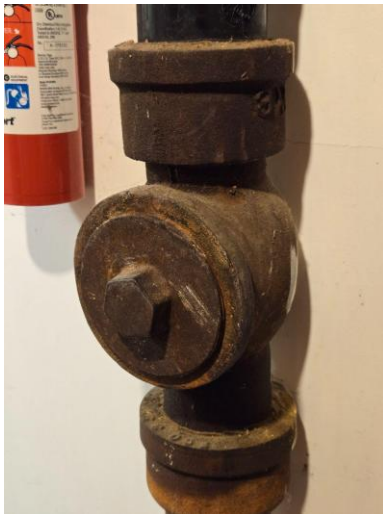
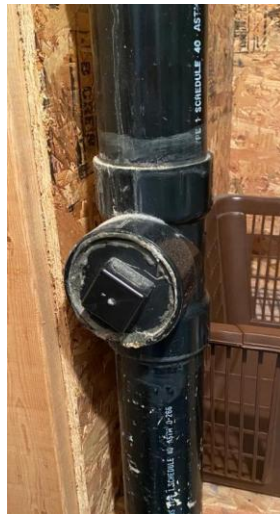
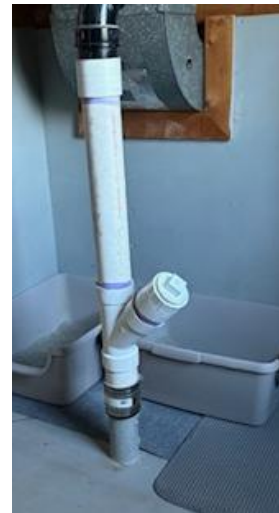
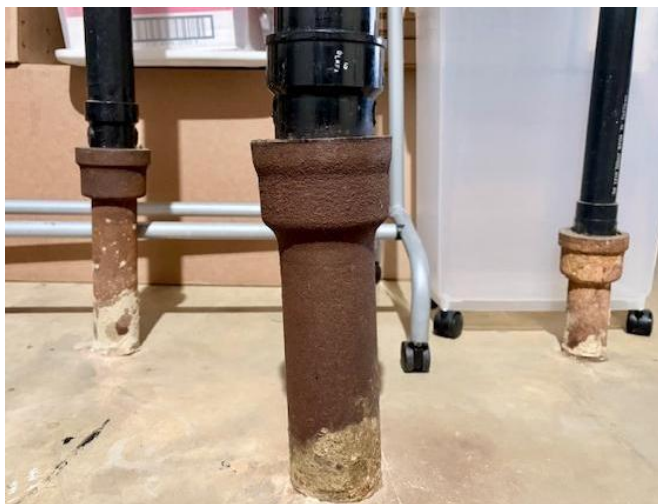
The primary waste pipes as originally installed in our community are cast iron and ABS. Originally, they would have clean-outs of the same material, but some have PVC replacement sections reflective of corroded cast iron clean-out caps, pipe leaks, or basement bathroom remodeling work. One resident stated that a crack in her cast iron waste pipe was fixed inexpensively by a plumber with a topical application of a substance (a type of epoxy?) that has worked for about 10 years before the crack is starting to reappear. In our community, the secondary pipes appear always to be black ABS plastic composition. In the older homes they connect to cast iron pipes at floor level, but in newer homes the ABS pipes enter the slab.

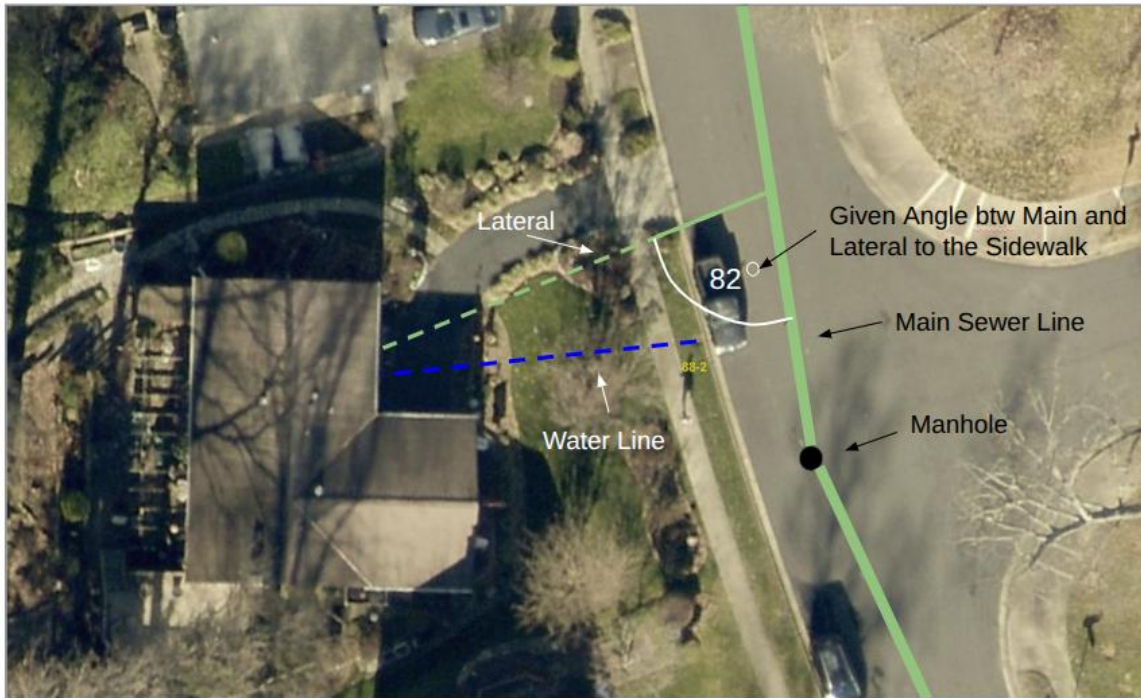
Laterals generally run in a straight line from the house to the main. You can estimate the lateral's path under your property by projecting a line from about where you believe the home's main collector waste pipe exits the foundation to the sidewalk junction revealed in the DPWES diagram. Any clean-outs in the yard will assist. I superimposed the diagram data I received from DPWES onto satellite imagery of my property and estimated that my lateral runs below the driveway, low planter stone walls, flower beds, and possibly my sidewalk lamp post!

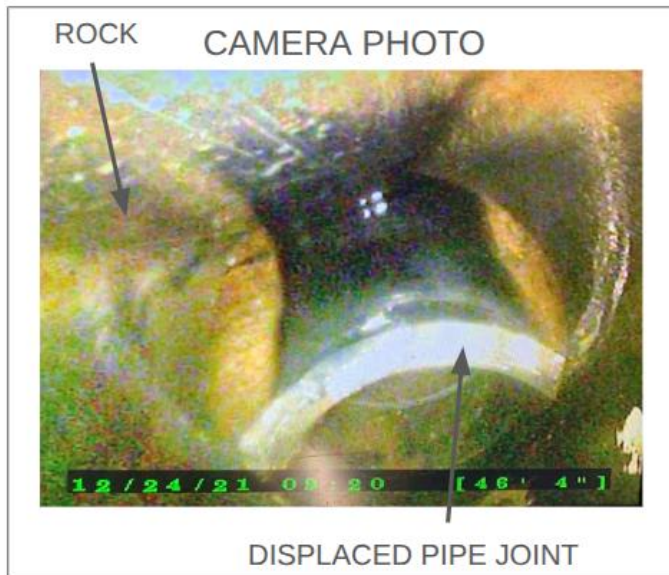
The camera photo shown here came from the lateral camera video taken by F. H. Furr at the Game Lord Dr home. Long's Corporation did the spot trench repair at a cost of \$6,600 (2026 = \$8,000+), which was entirely covered by the homeowner's HomeServe warranty. The homeowner was very satisfied with his experience. F. H. Furr did not do the repair, because it is not in HomeServe's contractor network; Long's Corp is. I showed the video to a plumber I interviewed, and he identified the pipe as probably ABS.

A resident on Game Lord Dr experienced what appeared to be an ABS lateral pipe joint displacement in 2022, apparently caused by the pressure of a rock or possibly ground shifting. The rock clearly came from the excavated material during construction that was then used as backfill after pipe installation. This inadvisable practice of using excavated material as backfill in contact with pipe is no longer permitted by code. Fairfax County now requires a bed of approved crushed stone or gravel to provide permanent, uniform support along the entire length of a lateral.
